PVC Piping: The Ultimate Underground Solution

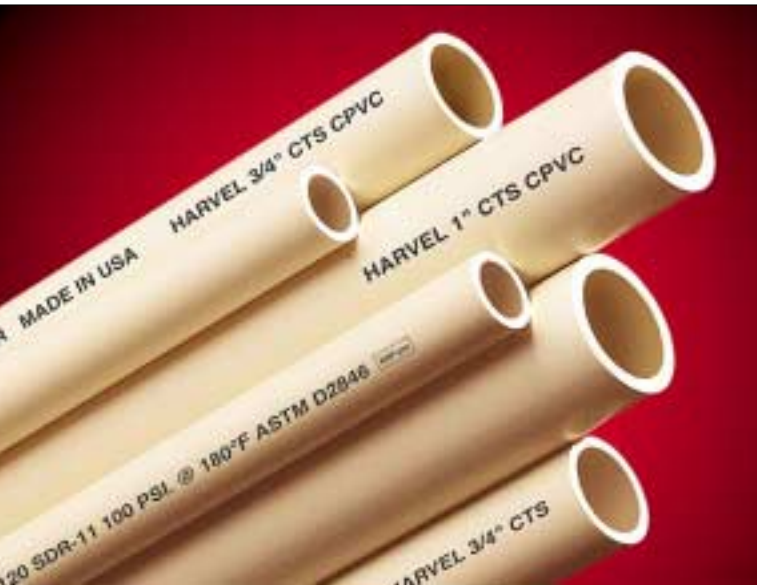
Copper-tube-size (CTS) CPVC piping features corrosion resistance for hot and cold water plumbing applications.
